Case Studies of Blistering Problems in Zinc-plated Steel and Zinc-plated Die-cast Zinc Alloy Parts

by Z. Panossian* & J.V. Ferrari

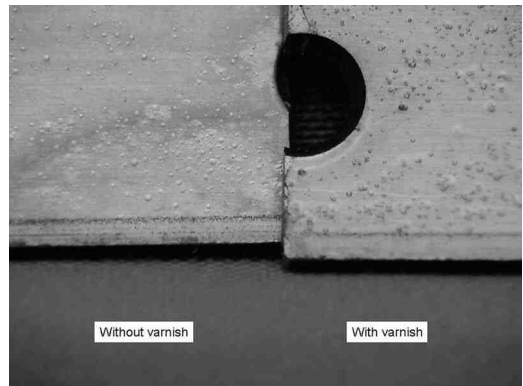
Figure 1—Surface view of a blistered part with and without varnish layer. The blisters remain visible after removal of the varnish layer, indicating that it is not present at the zinc/varnish interface.

The varnish layer on a surface of a part showing blisters was removed with the appropriate organic solvent. After this procedure, the blisters were still visible, as can be seen in Figure 1.

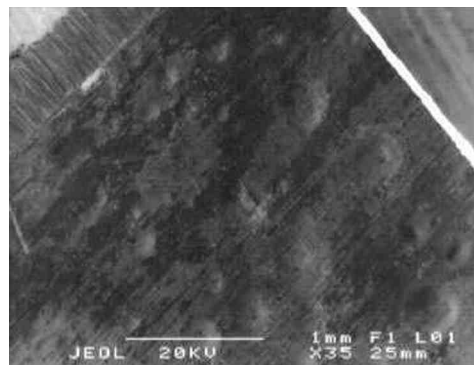
(SEM). Figure 2 shows the results, indicating the presence of blisters. This same surface was analyzed by energy dispersive spectroscopy (EDS) connected to the SEM. Through this analysis, it was possible to verify the presence of the following elements: zinc, chlorine and oxygen. Very probably, the chlorine originated from chemical cleaning in perchloroethylene. This solvent can decompose, yielding hydrochloric acid, which is aggressive to zinc, and phosgene, which is toxic.¹

Figure 2—Blisters shown in Fig. 1 without varnish. SEM, magnification: 35X. No etching.

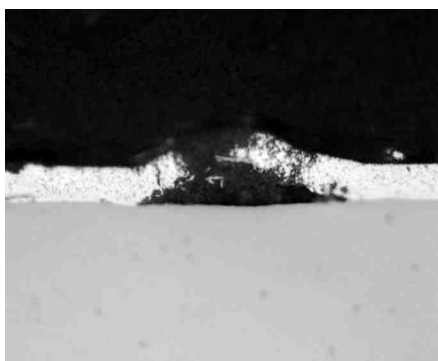
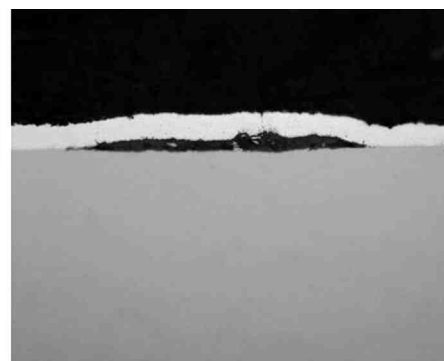
The cross-sections of the blistered parts were examined with an optical microscope. The blisters were present at the steel/zinc interface as shown for two separate sites in Fig. 3. No part surface defect could be seen that correlated with the blistering.

Discussion. We concluded that the blistering arose from hydrogen gas that was trapped at the steel/zinc interface. This occurred at weakly bonded areas between the steel and zinc, which were localized adhesion faults.

The process inspection indicated that the adhesion faults were caused by inadequate pre-treatment procedures. The chemical surface preparation involved:

Figure 3—Cross-sections of blistered parts showing separation at the steel/zinc interface. Magnification: 1000X. No etching.

Improvements in the pre-treatment process were recommended to the plater, including the continuous removal of the oil layer from the alkaline cleaner bath and racking the parts for plating from the beginning of the production process.

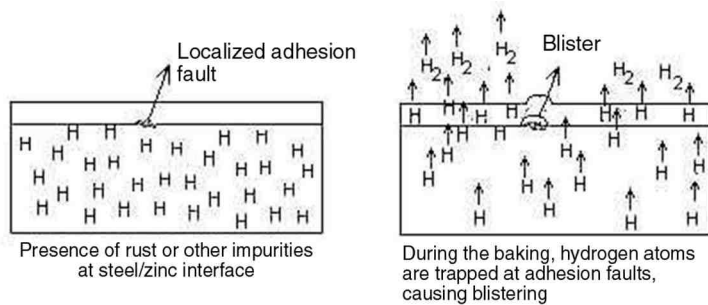
Figure 4—Schematic illustration of blistering a localized adhesion fault at the steel/zinc interface.

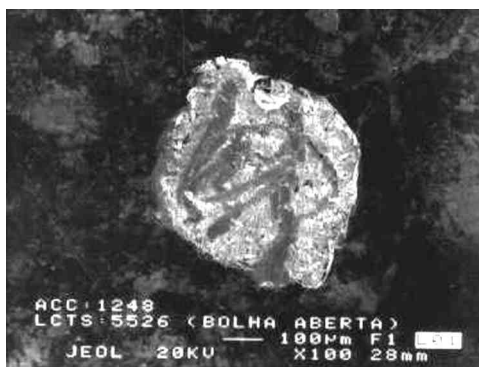
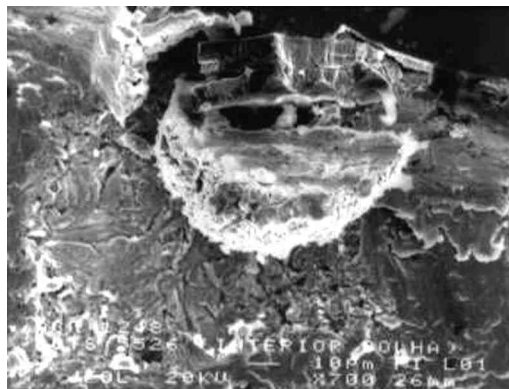
Figure 5—A blister after removal of the zinc coating. The scratches are due to the tool used. Magnification: (Left) 100X; (Right) 700X. No etching.

Experimental procedure and results. Both blistered and non-blistered parts were subjected to the following tests and analyses. A blister was examined with a scanning electron microscope after mechanically removing the zinc coating (Fig. 5). It was possible to verify the presence of solid products on the die-cast zinc alloy surface where the blister was removed. These products were subjected to EDS analysis by a spectrometer connected to the SEM. The presence of the following elements was verified: zinc, aluminum, copper, silicon (elements present in the zinc alloy) and oxygen. The latter indicated the presence of corrosion products.

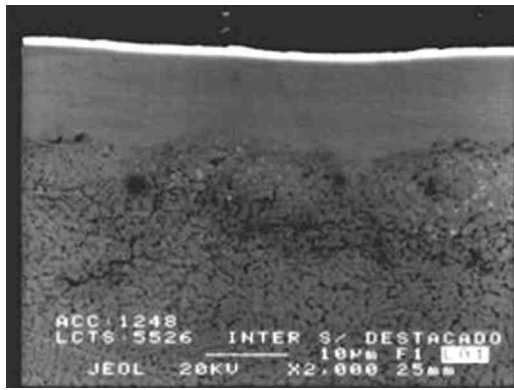
The cross-section of a blistered part was also examined. The surface of the die-casting exhibited several defects, pores (Fig. 6) and small cracks (Fig. 7). In some regions, these defects were very pronounced. At these points, the detachment of the coating from the substrate was observed (Fig. 8). Regions with and without defects were subjected to EDS analysis and the results indicated a higher oxygen content in the defects.

Figure 6—Cross-section of a blistered part, showing high porosity in the die-cast alloy. Magnification: 2000X. No etching.

parts, it is recommended that the surface quality of the die-castings be improved. Further, drying of parts after cleaning should be avoided.

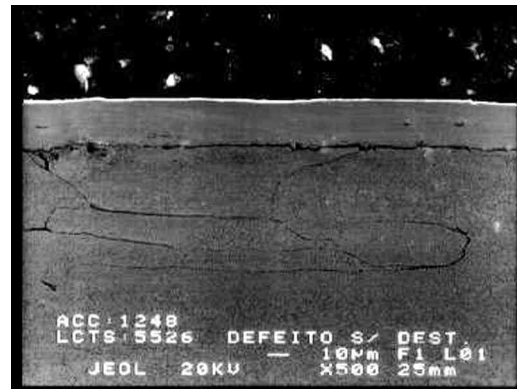
Figure 7—Cross-section of a blistered part showing cracks in the die-cast alloy. Magnification: 500X. No etching.

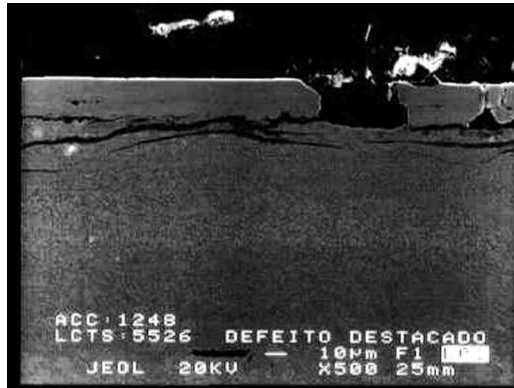
Figure 8—Cross-section of a blistered part. Cracks in the die-cast alloy caused the detachment of the coating. Magnification: 500X. No etching.

Discussion. The blistering arose from hydrogen gas trapped at the die-cast zinc alloy/zinc interface. As with the steel parts, this occurred at weakly bonded

areas of the zinc coating. In this case, defects on the die-cast zinc alloy surface were the cause of the adhesion faults.

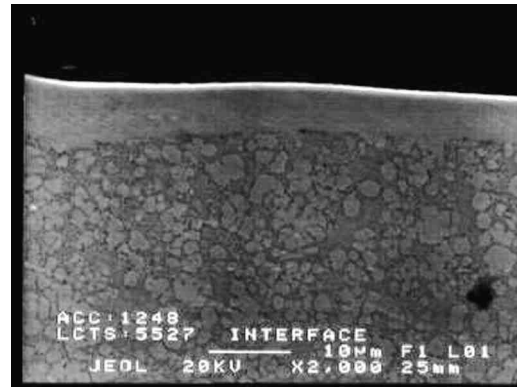
The cross-section of parts with a different design and which showed no blisters was also examined with the SEM. No defects were observed near the substrate/coating interface (Fig. 9).

Figure 9—Cross-section of parts with a different design which showed no blisters. No defects were observed on the zinc alloy surface. Magnification: 2000X. No etching.
