"Measles Outbreak"

Frank Altmayer, MSF, AESF Fellow

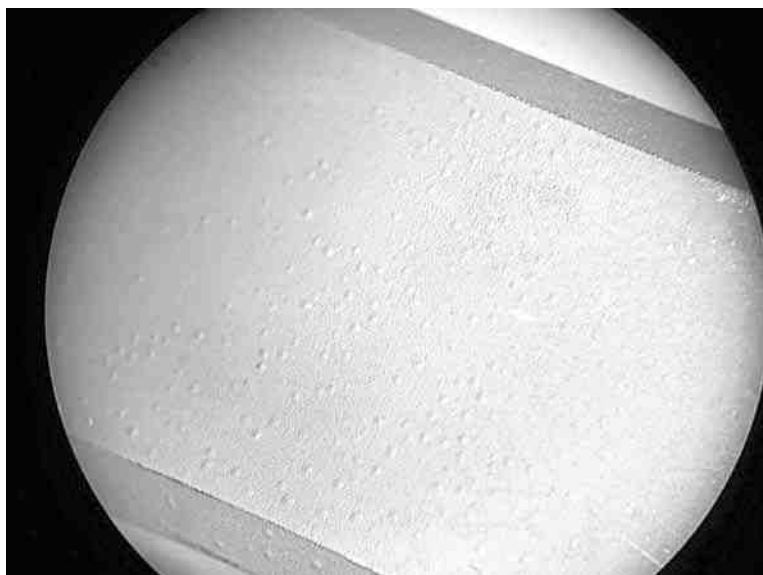
After several weeks of production, parts show very small blisters only after baking (See photo.). These usually show up within the first 60 minutes of baking. The blisters are uniformly dispersed and do not appear to be related to current density or part geometry, but they do seem to be far more prevalent over ground or blast surfaces versus machined surfaces.

In your case, we investigated several parts and found that the blisters were located between the basis metal and the initial plated deposit. We also found that some parts had far more plating than specified (three times too much). Further, the solution you are using has an additive package that includes brightener(s) and other organics. We therefore concluded

that the blistering was caused by hydrogen gas which could not readily diffuse through the deposit during the baking because the deposit was not porous enough. Instead, the hydrogen gas expanded and "pushed" up on the deposit, creating the blisters.

We dug a bit deeper into your process and found that organic additives were being added under less than optimum conditions. Normally, the additives are added based upon ampere-hours of operation, while you were adding them based upon visual interpretation of Hull Cell panels. We suspect that this visual method resulted in the addition of large amounts of additives. After a few weeks of operation with this visual control, the organic content of your solutions would reach a level where the deposit was too "dense" to allow for hydrogen diffusion.

1. The anode cathode ratio should be controlled by measuring the surface area of the parts and making sure the ratio is less than 2:1, preferably 1.5:1
2. Consider baking the parts before plating and consider baking twice - first after applying a thin (0.0001"; 2.5 μm) deposit then applying the majority of the deposit.
3. The current density needs to be more carefully controlled.
4. Additives should be added based on ampere-hours.
5. Keep the brightener concentration as close to zero as possible (be careful not to infringe upon the Boeing patent).
6. Consider increasing the nickel content to near 10%.
