## Plating & Surface Finishing Retrospective

### Fickle black oxide

### Small blind holes

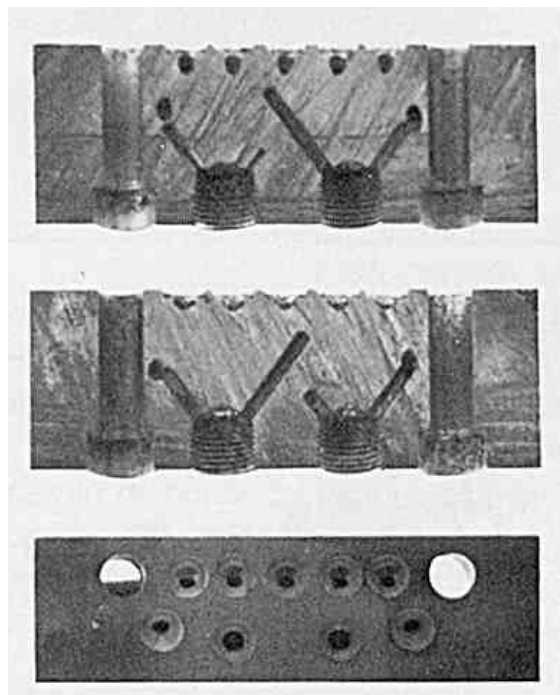
**Q:** I'm sending you some blocks (Fig. 1) that we chloride zinc plate. One has been cut in half to show you the blind holes that are giving us so much trouble. We do excessive rinsing, hot and cold, use air agitation and apply a lubricating oil on the last step. Solution still runs out of the block, causing part rejection. Any ideas?

Figure 1—Block with blind holes; at bottom is a surface view; the top and middle photos show a cross-section of the same part cut in half. Part is about  $1.25 \times 4.0$  cm.

John Laurilliard of SPS Technologies, Jenkintown, PA, also took a look at your parts. Here's what he says: "We found that only two of the small holes at the bottom of the tapped holes are actually blind. All the other small holes exit through a larger hole. The route was determined by pumping ethyl alcohol solvent from a plastic squeeze bottle through each hole and observing the exit point. Only two holes, one in each of the threaded holes, were blind.

"As Mr. Kornosky has indicated, the standard practice of alternate rinsing in hot and cold water will normally suffice if the diameter of the holes is not so small that capillary action prevents free drainage of trapped solution. An evaporation technique using elevated temperature or vacuum will remove water but may leave the salts behind. These will later absorb moisture from the air and 'bloom.'

**A:** This is a tough one. Since you've already tried hot and cold water rinses and air agitation, perhaps an ultrasonic rinse, although expensive, may help to remove contaminants. An extended drying time to evaporate all the liquid in the holes may help too.

"Mechanical removal may help you. Parts could be stacked in a spinner basket and centrifuged to remove the solution. A second or even a third subsequent cold water rinse followed by additional spinning may be necessary.

"Another technique involves rinsing parts in either methyl or ethyl alcohol, which are miscible in all proportions with water. Several such rinses may be necessary to totally remove the water. Displacement methods may also be helpful. Water displacement can be accomplished using Freon solvents. The high density and low surface tension of Freon TF solvent and a hydrophobic surfactant enhance water separation.

"If all the above fail, you may be forced to use a direct selective-rinsing technique. You will have to construct a small-diameter rinsing device. Two hypodermic needles soldered to a piece of copper tubing and fitted to a trigger hose nozzle work well for rinsing out blind holes. The parts should be unracked after the final rinse, the blind holes rinsed using hypodermic needles and, finally, the entire part rerinsed to wash off the solution that emerges from the blind holes. A similar device may be used to blowout and dry the blind holes with compressed air." Mr. Laurilliard concludes.

As a final thought, perhaps you should check with the part designer. A rule of thumb would be to limit blind holes to 50% of their diameter, and avoid blind holes with a diameter of less than 0.56 cm ( $1/32$  in). Not only is rinsing a problem when holes are too small, electrodeposition becomes a difficult practice in these spots. Quality products require quality design! Without this, the type of problem you have is bound to occur.
