## Now That's What I Call Burning!

**Frank Altmayer, MSF, AESF Fellow**

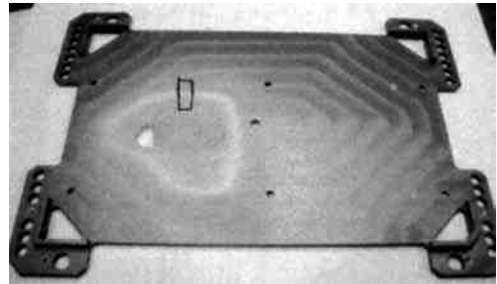
One test coupon out of 54 "burned." The burning is a localized eating away of the material as if it was sitting in acid. The burned test coupon was the MIC-6 material. The remaining pieces showed no signs of burning. These results are consistent with results of hard coat anodizing our MIC-6 parts. Only a limited percentage of the parts burn, the rest are OK.

Figure 1—MIC-6.

In this particular case, there is nothing that you as the anodizer can do to solve this problem as it appears that a significant percentage of your parts have a flawed microstructure. I might also add that our laboratory has received other samples from other anodizers that were experiencing anodizing problems with MIC-6 alloy, so it appears this may be a problematical material for anodizing. *P&SF*

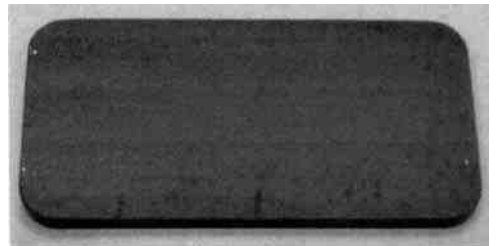
Figure 3—K-100.
