## **Servicing a Hard Chromium Plating Operation**

*Ray Kern, MacDermid, Inc., New Hudson, MI, USA*

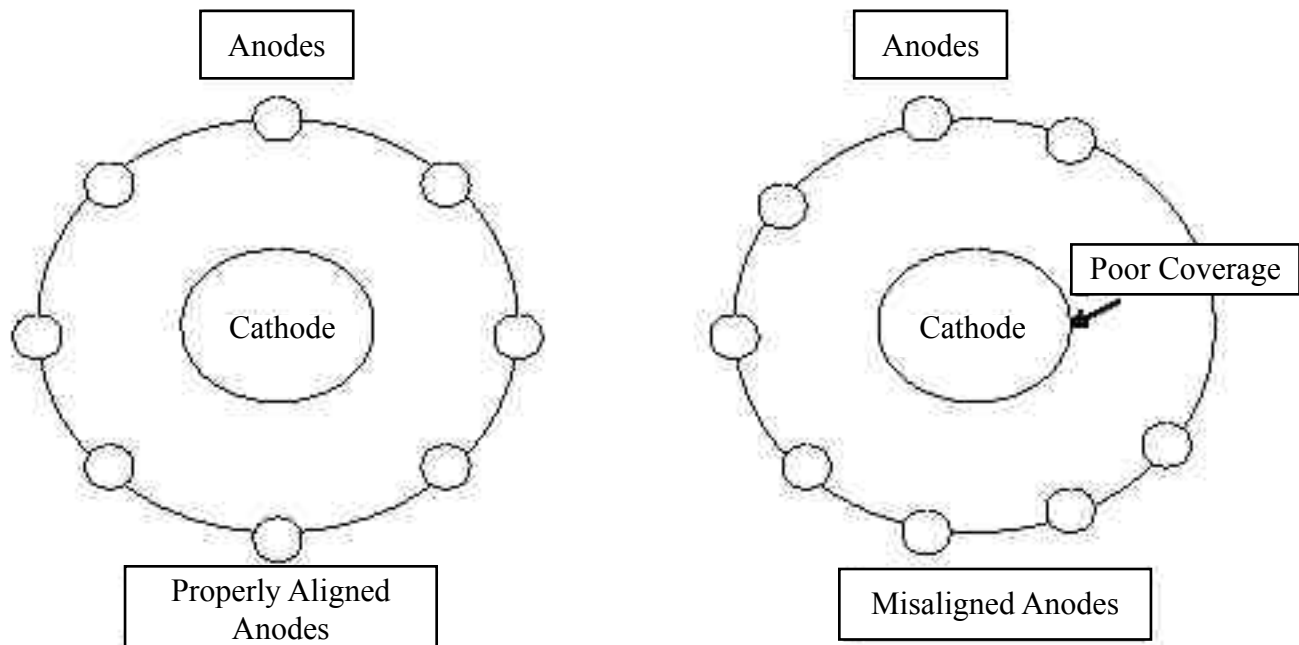
Poor coverage can also be caused by scaled or passive anodes or anodes that are misaligned. As was mentioned before, lead alloy anodes that are in contact with a chromic acid solution when no current is being applied to them, will immediately begin to scale with lead chromate. If it is not too thick, this lead chromate scale can be removed by dummifying the plating bath at operating temperatures and current densities for approximately 15 minutes at the beginning of each shift. After extended periods of down time, however, it is possible that the lead chromate film becomes too thick to remove by dummy plating. If that is the case, it will be necessary to remove the anodes from solution and chemically clean them using a proprietary anode cleaner. Anodes that are scaled with lead chromate should not be cleaned mechanically since, lead chromate dust is hazardous. In addition, mechanically cleaning anodes can create grooves on the surface that can affect the current density applied to the parts. If the anodes are active they will be coated with a brown, black coating of lead peroxide. Next, check to see that the anodes are aligned properly. Current flows in the system using the path of least resistance. Therefore, it is necessary to space anodes in a way that all areas of the part receive the same current distribution from the anodes.
