# Exterior Decorative Coatings Improvements on Commercial Airplanes

by  
Elden Altizer\*  
Material & Processes Technology  
Boeing Commercial Airplanes,  
Seattle, WA, USA

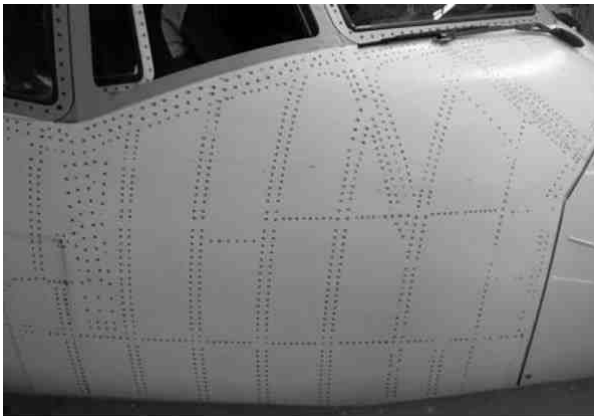
Figure 1—Severe “rivet rash” by flight deck window.

The selective loss of paint adhesion on aluminum rivets, shown in Figure 1, is known in the aerospace industry as “rivet rash.” This condition has existed to varying degrees since the beginning of the jet aircraft age. It is such a common condition that there is a good chance that every reader has boarded an airplane with rivet rash and never given it a thought. But rivet rash started to appear earlier and more severe after the change to ANESHAP\*\* compliant coatings.

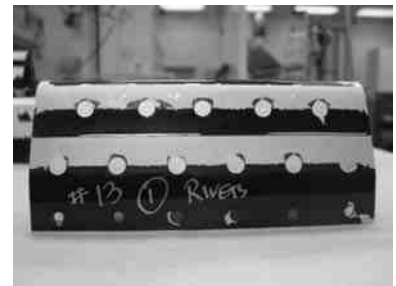
Figure 3—Standard rivet finish.

Rivets were installed in test foils for the Boeing Whirling Arm Rain Erosion test, which subjects foils to simulated rain at high speed. A decorative paint system was applied to the foils and the adhesion to the rivets was noted. Figures 3 and 4 show a dramatic improvement in adhesion provided by the sol-gel coating.

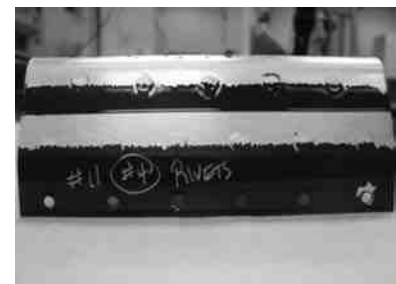
Figure 4—Sol-gel rivet finish.

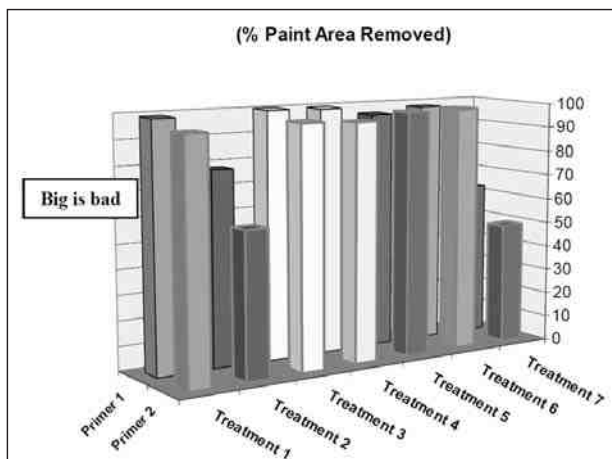
Figure 6—The effect of the standard aged rivet finish as painted in production.

The benefit of the sol-gel technology for promoting primer adhesion on rivets that are prepared with different cleaning processes (defined in Fig. 5) and primers are shown in Figs. 6 and 7.

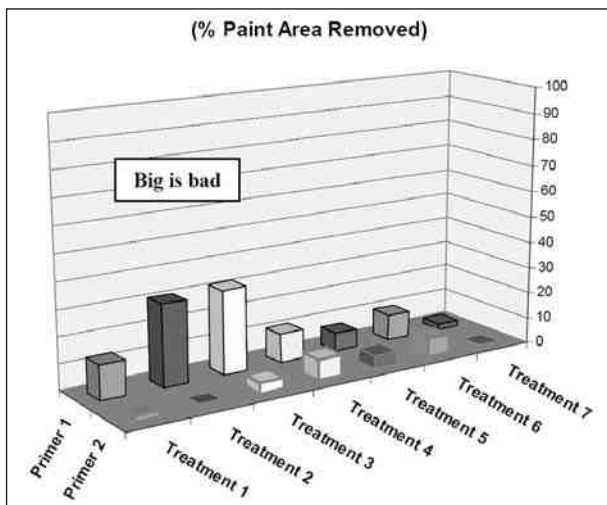
Figure 7—The effect of the rivet new sol-gel finish as painted in production.

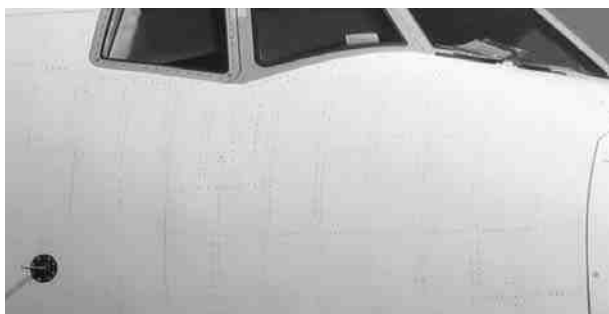
Figure 9—Rivet rash on a Boeing 777 painted prior to sol-gel rivet conversion after 18 months in-service.

The year following the implementation of the new rivet coating, Boeing surveyed the performance on various models operating in Europe, Asia and North America. The results were encouraging as the onset and occurrence of rivet rash was significantly lower than prior to the sol-gel coating, but it was not completely eliminated (see Figs. 9 and 10).

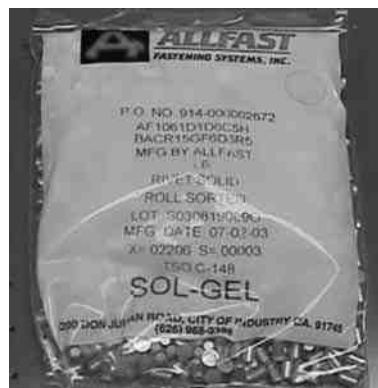
Figure 8—Standard one pound bag of aluminum rivets with sol-gel noted on packaging.

The new sol-gel finish was implemented in early 2003 on all aluminum fasteners produced by Allfast, the sole supplier to Boeing and our parts suppliers. Since the clear sol-gel coated rivets are not visibly different from the non-sol-gel, the main tool to identify them is by the packing as shown in Fig. 8.

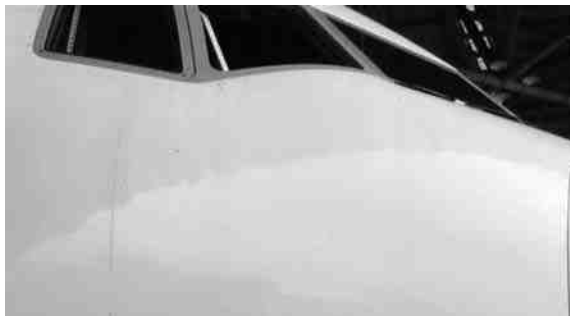
Figure 10—Minimal rivet rash on a Boeing 777 painted after sol-gel rivet conversion after 14 months in-service.
